**CANADIAN FORCES
FLIGHT SAFETY INVESTIGATION REPORT**

FINAL REPORT

FILE NUMBER: 1010-CT155216 (DFS 2-3-3)
DATE OF REPORT: 28 January 2005
AIRCRAFT TYPE: British Aerospace Hawk Mk-115 (CT155)
DATE/TIME: 041702Z July 2003
LOCATION: 15 Wing Moose Jaw, Saskatchewan
CATEGORY: "B" Category Accident

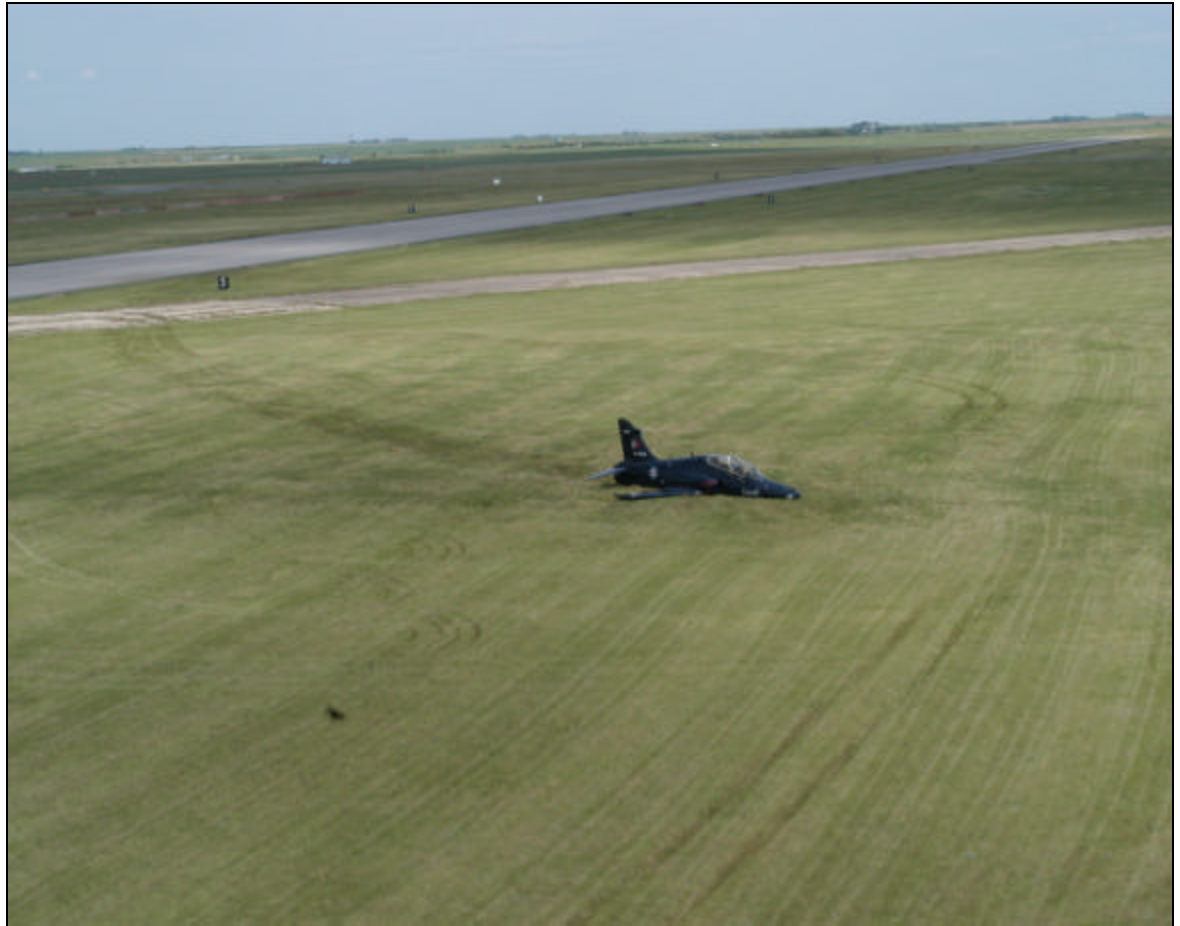
PHOTO 1: FINAL RESTING PLACE

Hawk1 landed on the centreline of runway 29R 1,000 feet past the threshold with the landing gear in the up position. The aircraft skidded on its' belly for approximately 4000 feet before exiting the left side of the runway and coming to rest in the infield 4720 feet from the touchdown point and 420 feet off the left edge of the runway. The pilot did not deploy the drag chute and did not eject from the aircraft. He exited the cockpit in the normal fashion and waited by the

The aircraft received B Category damage which required the aircraft be shipped to the contractor. Damage was mostly limited to the underside of the wing and the fuselage. The nose landing gear doors were eroded exposing the nose tire and allowing the aircraft to ride on the nose tire as it skidded along the runway and the infield. All lower antennae and flap hinges were scraped-off and the left flap was pushed upward.

The aircraft remained mostly intact throughout the accident. Only small external components were scraped off as the aircraft skidded along the runway and the infield and finally came to rest approximately midway between the runways as shown in photo 1.
